Screw Presence in the Fifth Metatarsal-Cuboid Joint After Intramedullary Screw Fixation of Acute Jones Fractures

Ridhi Mehta, DPM, Brian J. Burgess, DPM, FACFAS, Dana M. Berns, DPM, Amir K. Sepahdari, MD Mercy Hospital and Medical Center Chicago, Illinois 60616

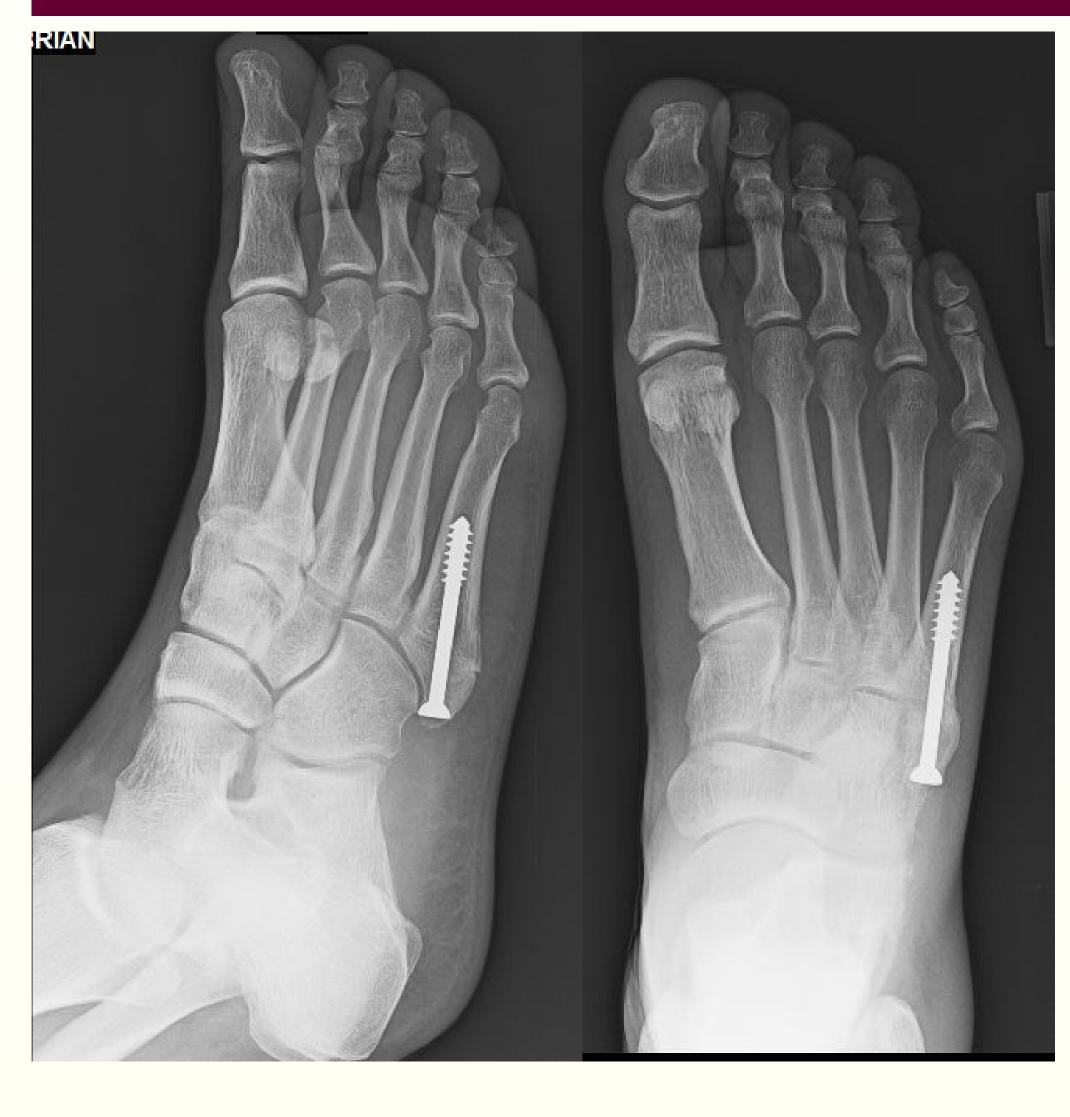
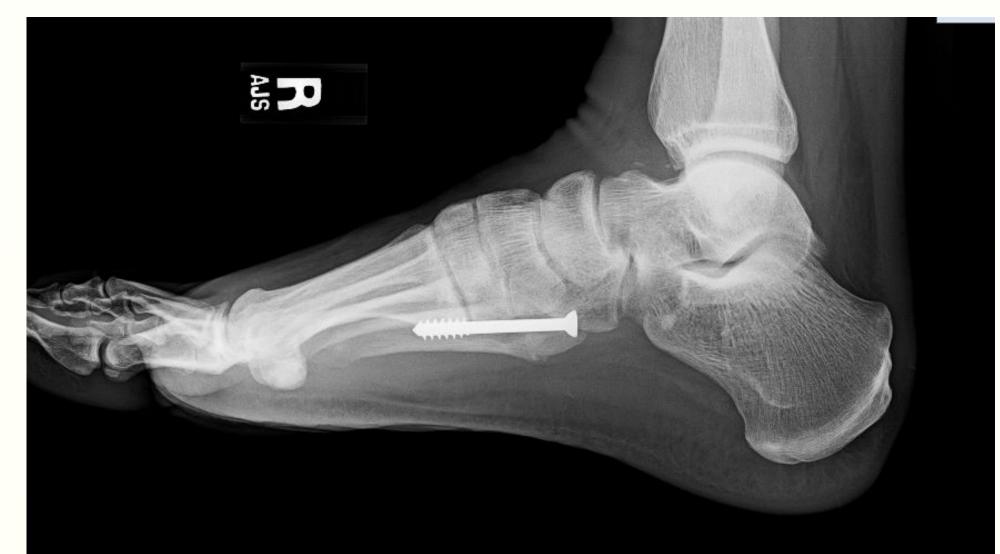
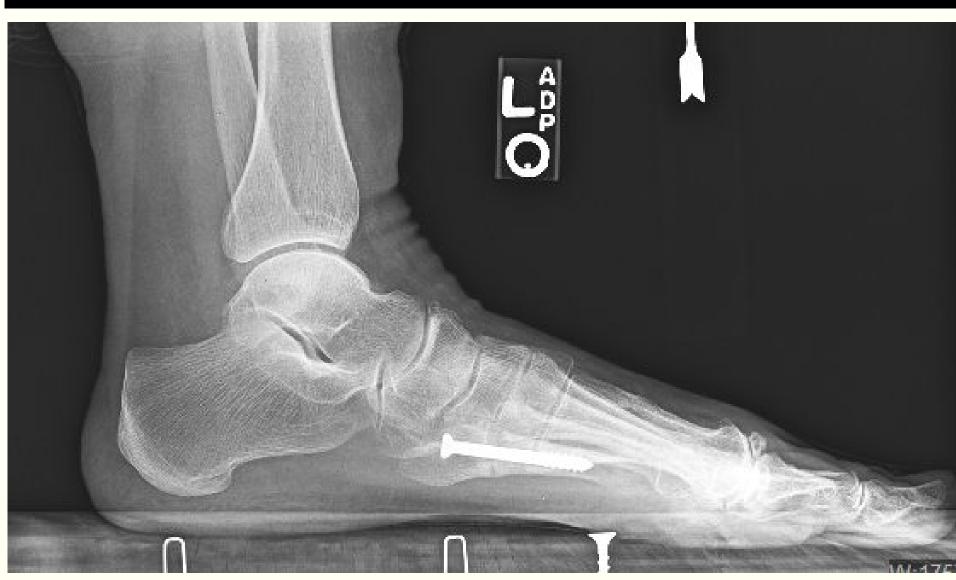
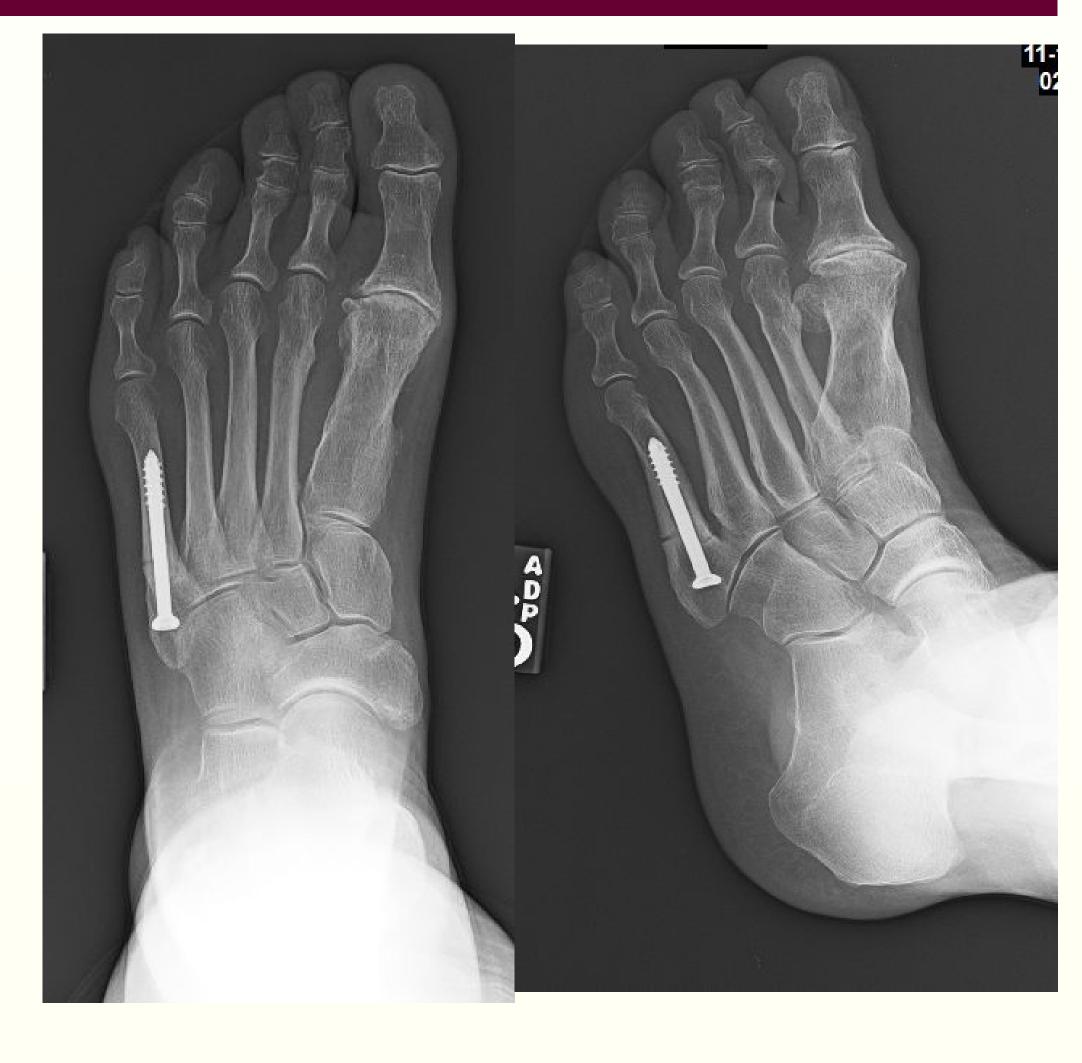
Examples of IM Screws Not Involving the Metatarsal Cuboid joint

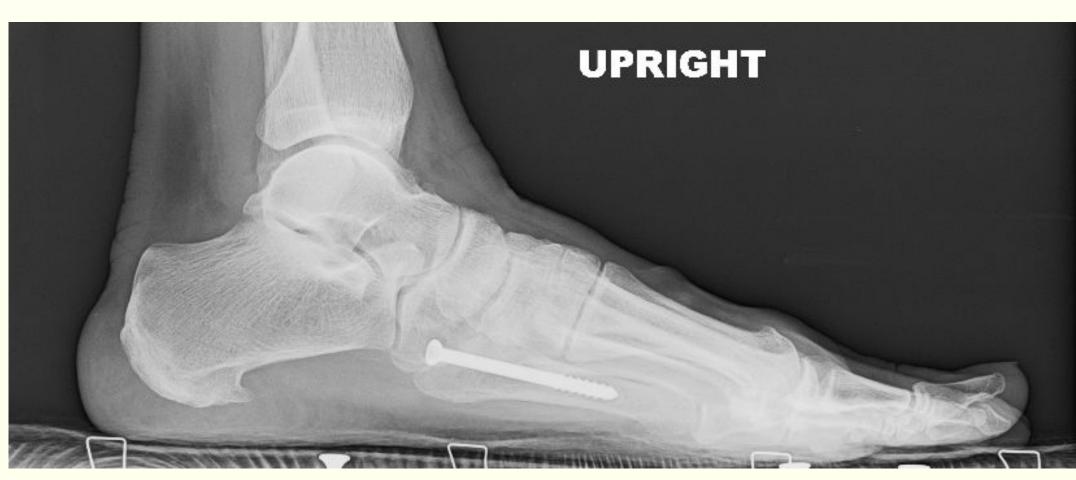
Examples of IM Screws Violating the Metatarsal Cuboid joint

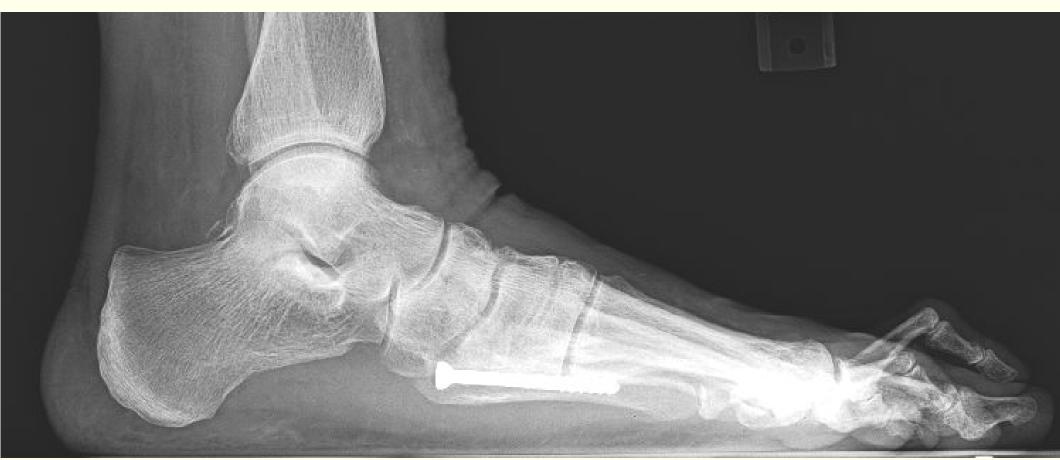
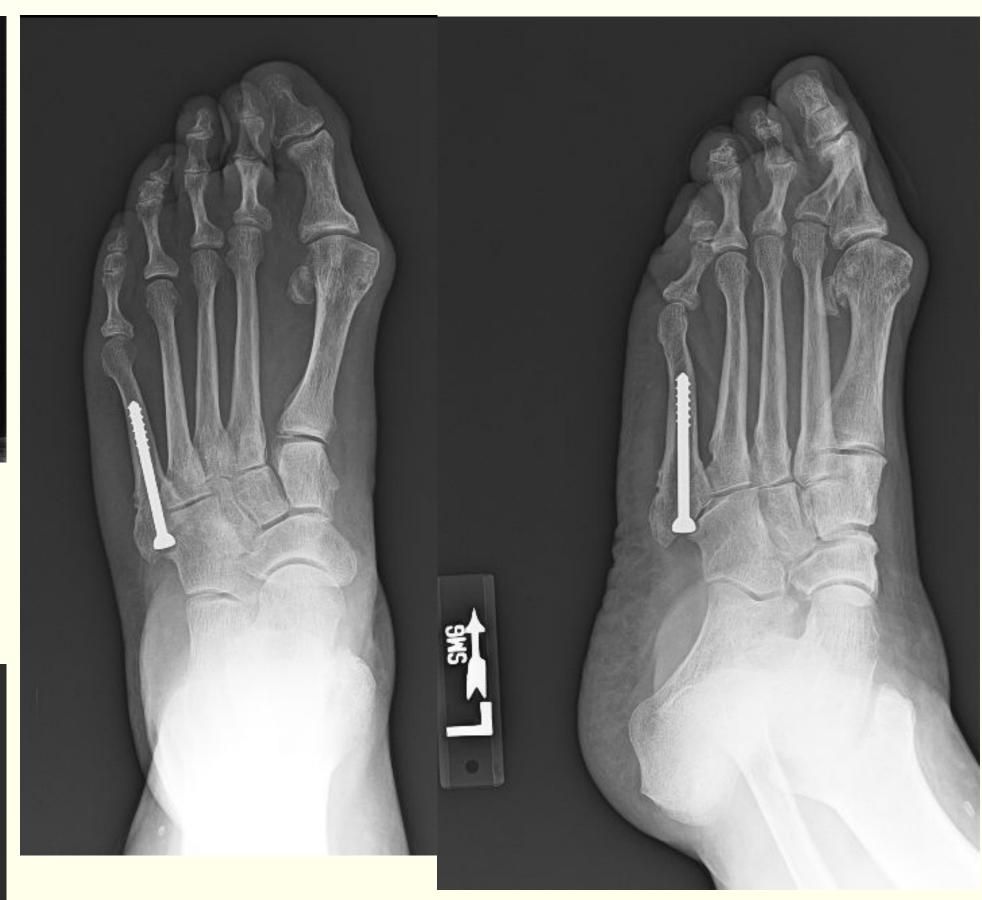
Example of an IM screw violating the joint. Also seen is resultant lucency in the cuboid from the screw head
