Salvage of failed Salto Talaris Total Ankle Replacement with anterior translation of the talus without replacing tibial component. DREXEL UNIVERSITY COLLEGE OF MEDICINE Hahnemann University HOSPITAL Richard Kaufman DPM¹, Alyssa Piccillo DPM², Steven Boc DPM⁵ FACFAS, FACFAOM ¹PGY3 Podiatric Surgery Resident, Hahnemann University Hospital / DUCOM, Philadelphia, PA ²PGY3 Podiatric Surgery Resident, Hahnemann University Hospital / DUCOM, Philadelphia, PA ³Attending Podiatric Surgeon and Director of Podiatric Surgery Residency Program, Hahnemann University Hospital / DUCOM, Philadelphia PA

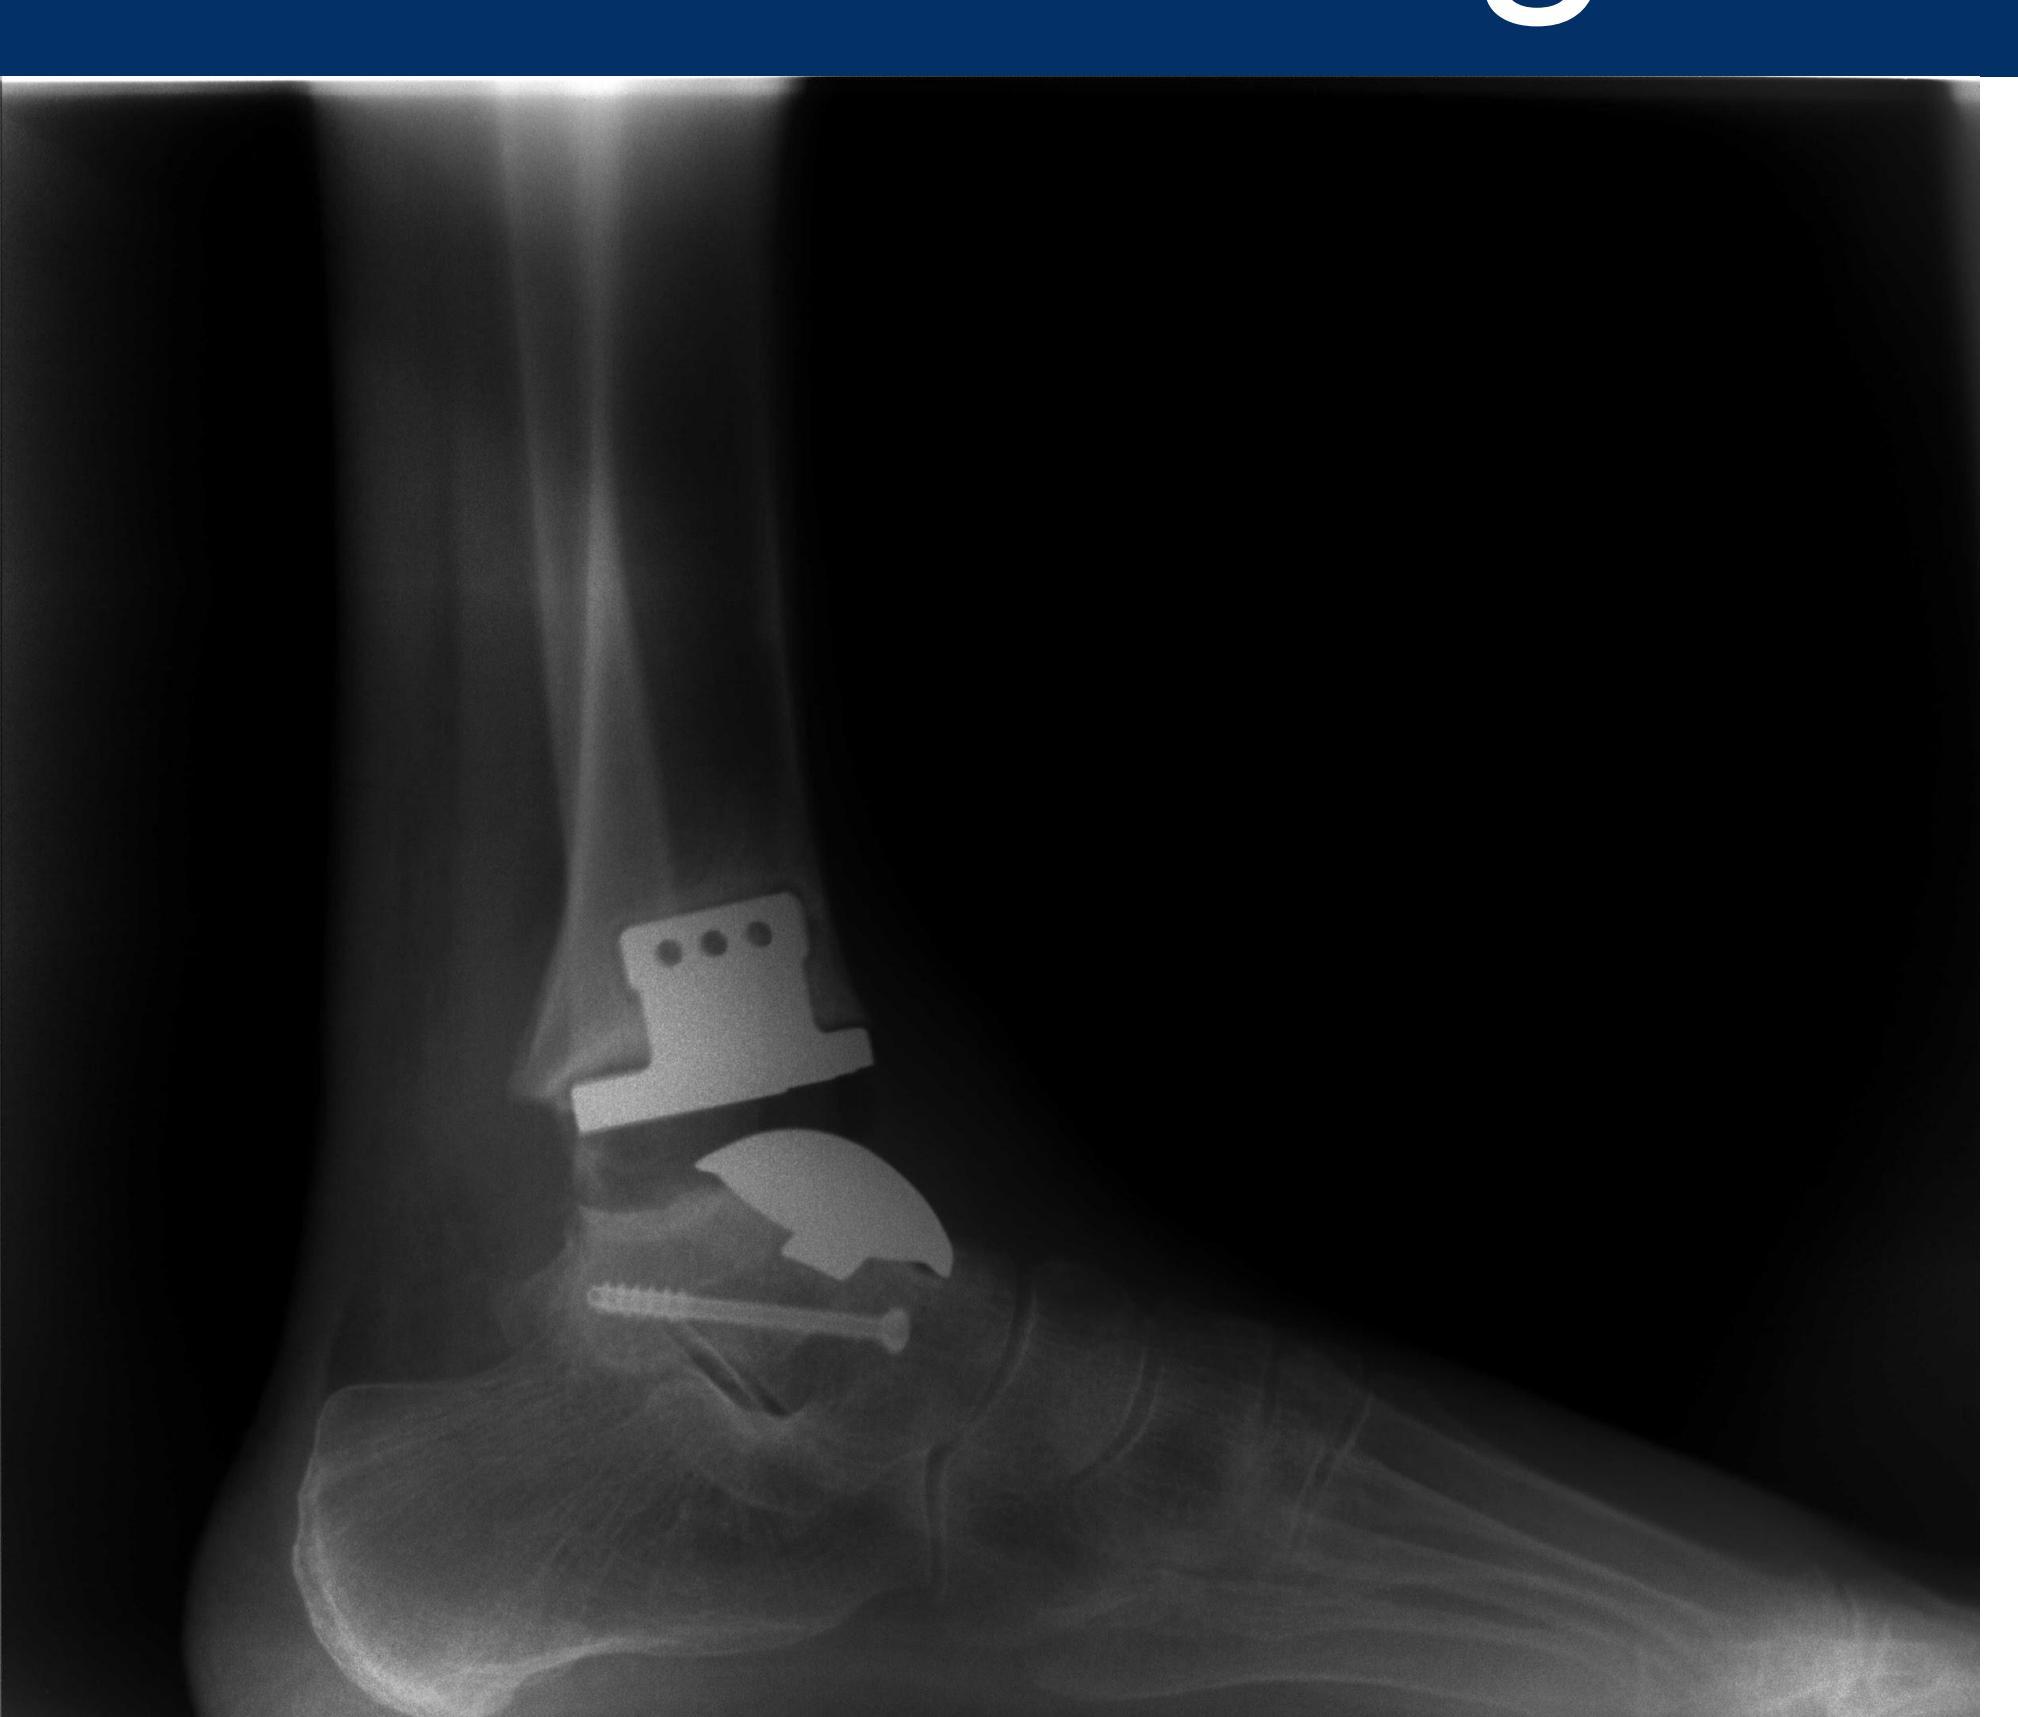
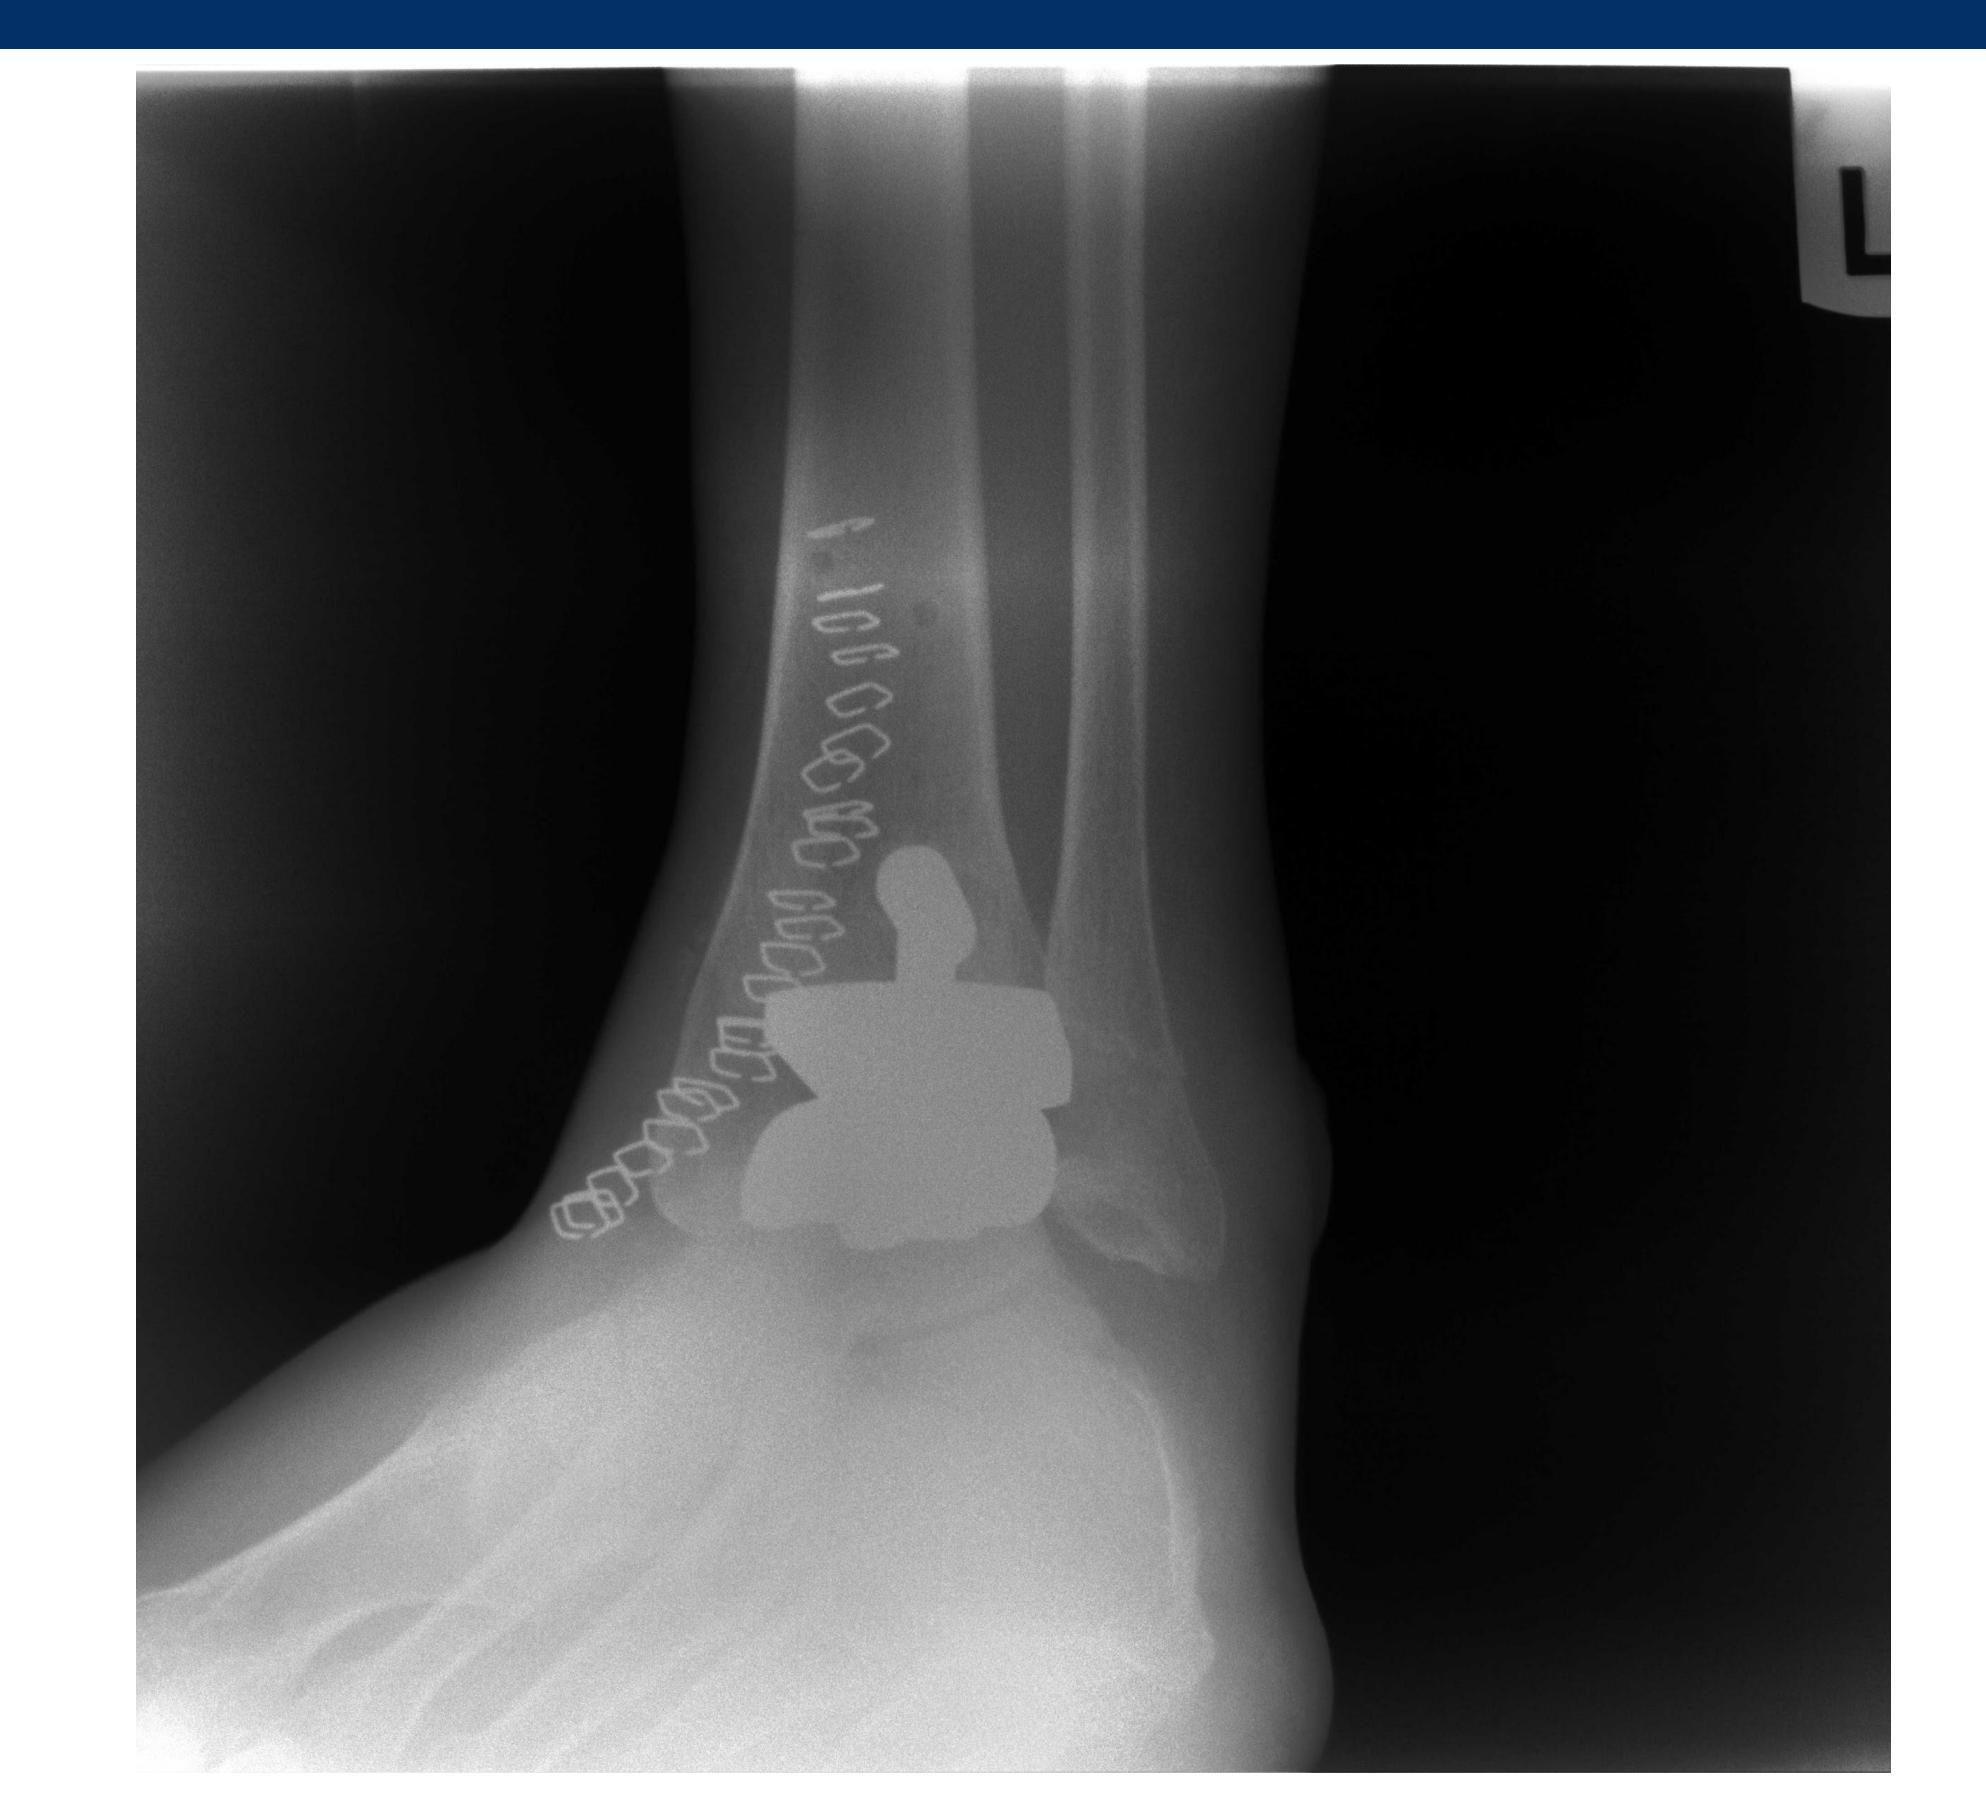
Figures 1a, 1b

We present a 57 yo female with idiopathic degenerative osteoarthritis of her left ankle who elected to undergo primary left TAR at our facility. Due to the patient's height and weight, a size 0 Integra Salto Talaris[®] implant was chosen for the patient. The primary TAR was uneventful, with no technical complications noted intraoperatively. Immediately, on post-op day 1, the patient began ambulating AMA and exhibiting significant signs of non compliance. After discharge from our hospital, two weeks post-operatively she fell down a flight of stairs, landing on her left lower extremity. The trauma to the ankle joint caused anterior displacement of the talar component leading to a Hawkins I talar neck fracture.

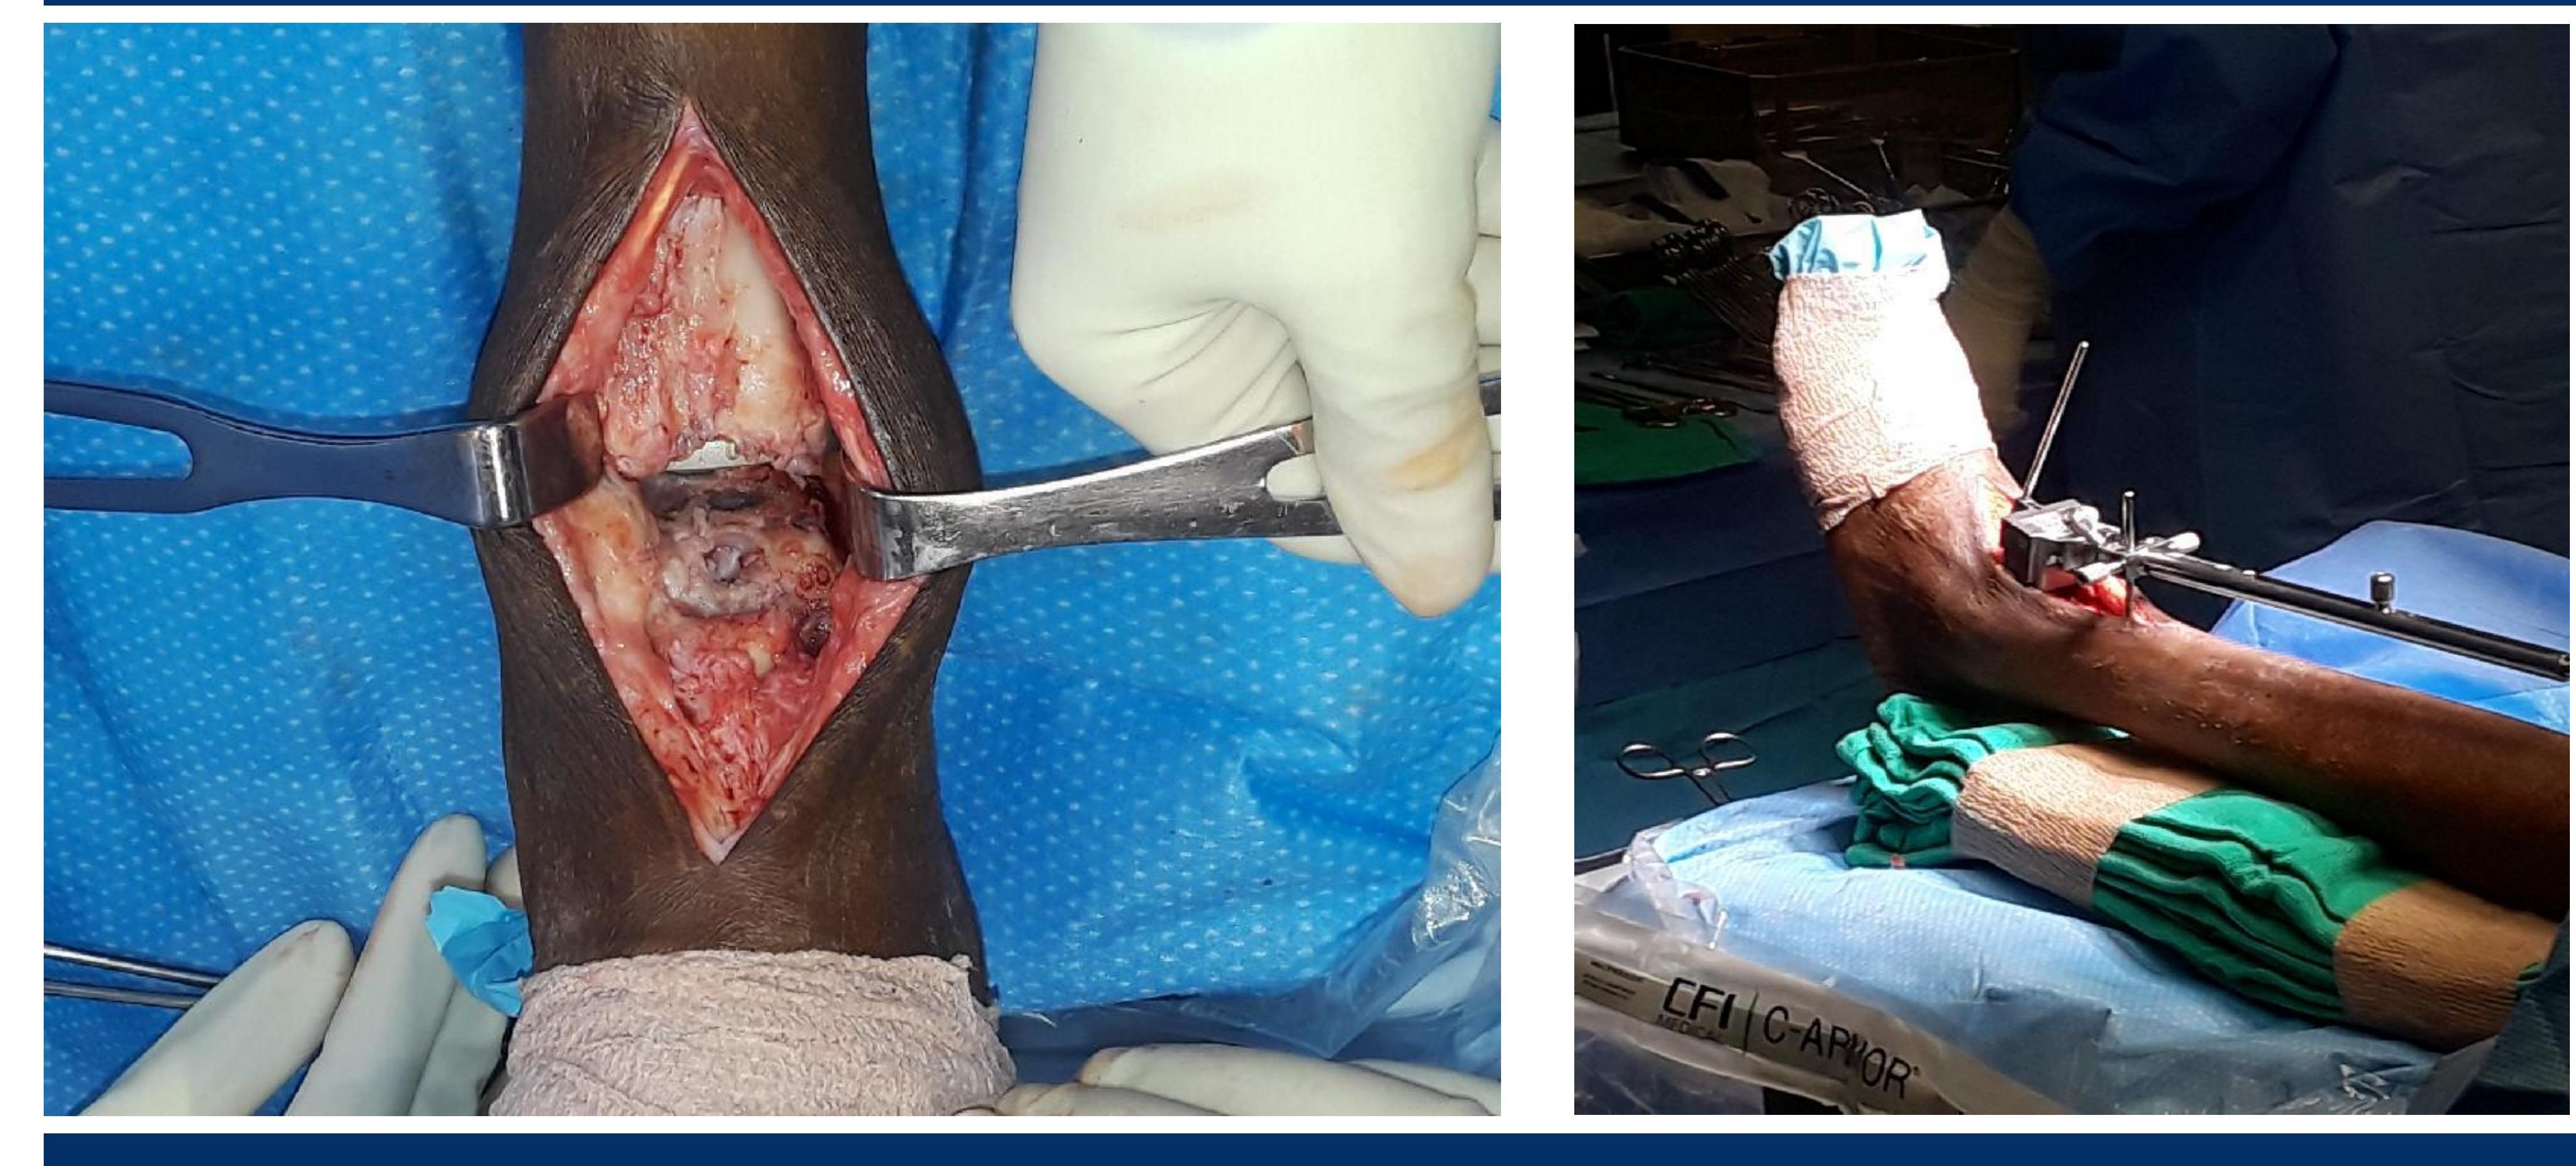
Figures 2a, 2b

while the patient no longer experienced pain upon palpation of the talar neck, significant crepitus and clicking was noted at the ankle joint, along with lateral tinting and edema of her skin at the ankle joint. Her neurovascular status was intact. She related significant pain upon ambulation and palpation of the ankle joint and was temporarily placed in a CAM boot / soft cast to reduce swelling. Revisional TAR was decided upon, however due to poor follow up by patient, revisional surgery was not able to occur until 11 months post primary TAR.
