# Revision of an Oregon Total Ankle Prosthesis 37 years later

Lawrence DiDomenico DPM FACFAS, Zachary Flynn DPM AACFAS, Matthew Daniel DPM

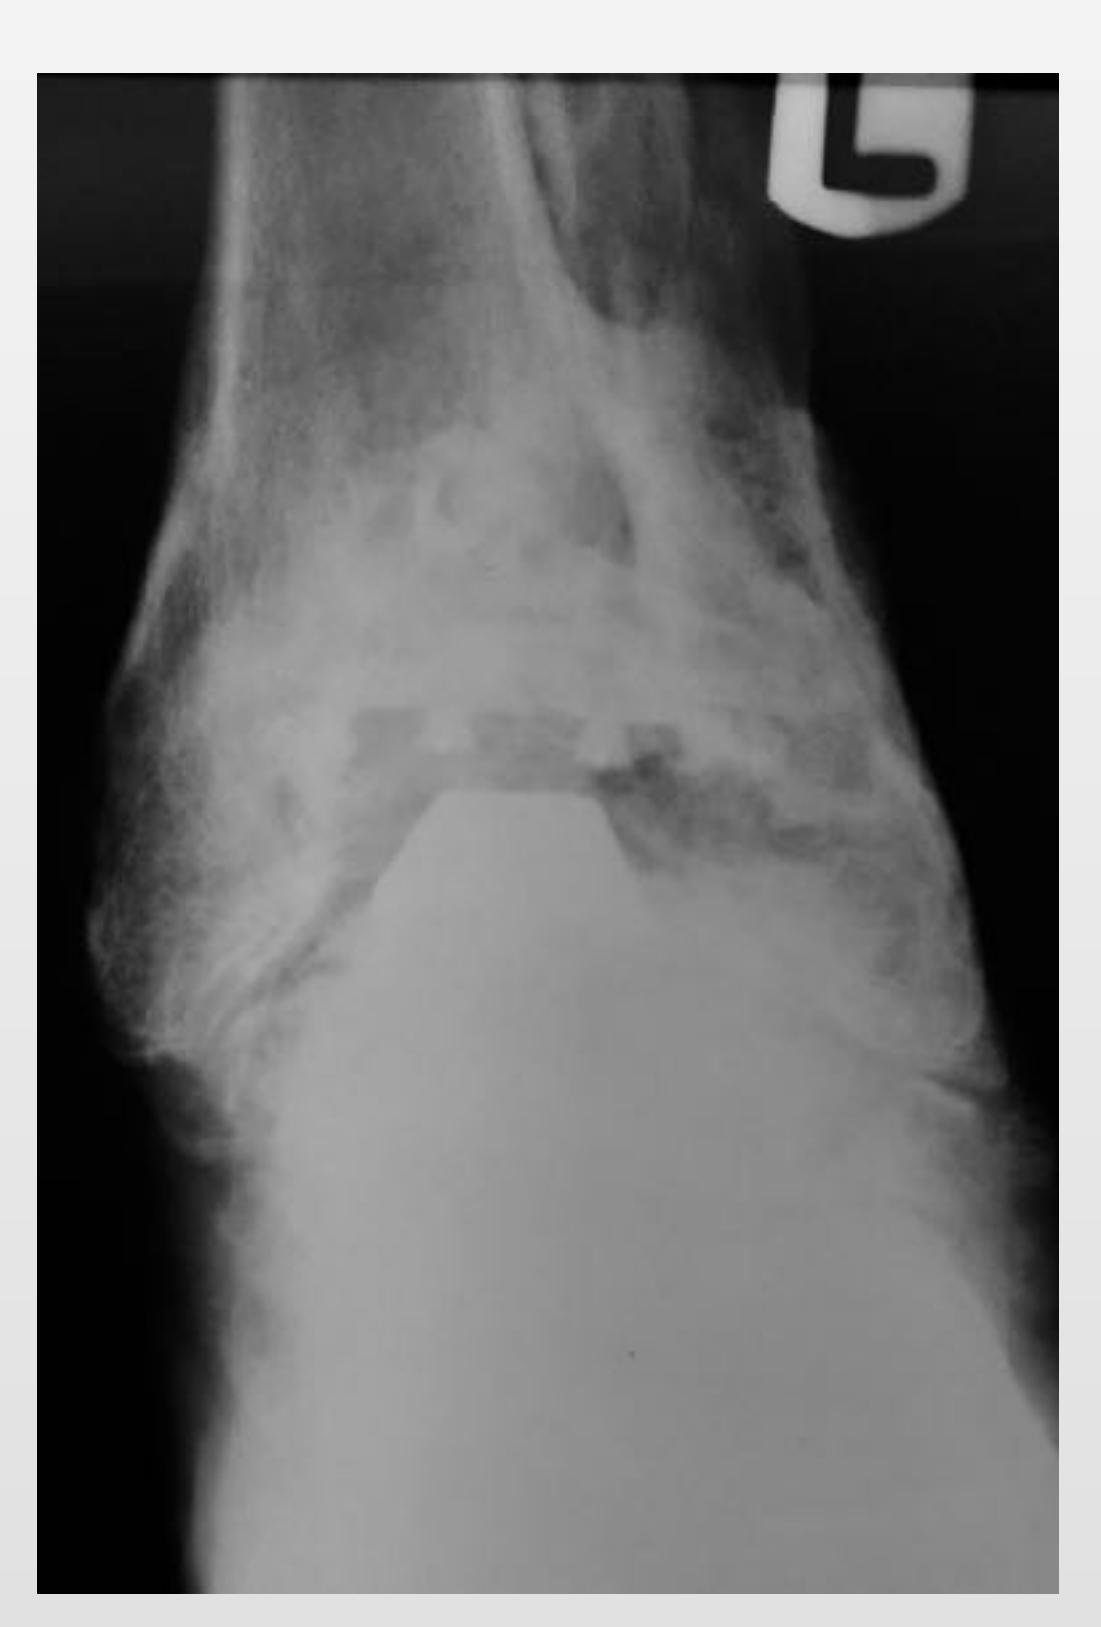
Photo1

**PHOTO 1, 2, & 3:** AP, Lateral and Oblique pre-op radiographs demonstrating the 37 year old implanted Oregon Ankle Implant. The radiographs display the hypertrophic bone formation, secondary mid foot arthritis and a relatively well maintained Oregon Ankle Implant.

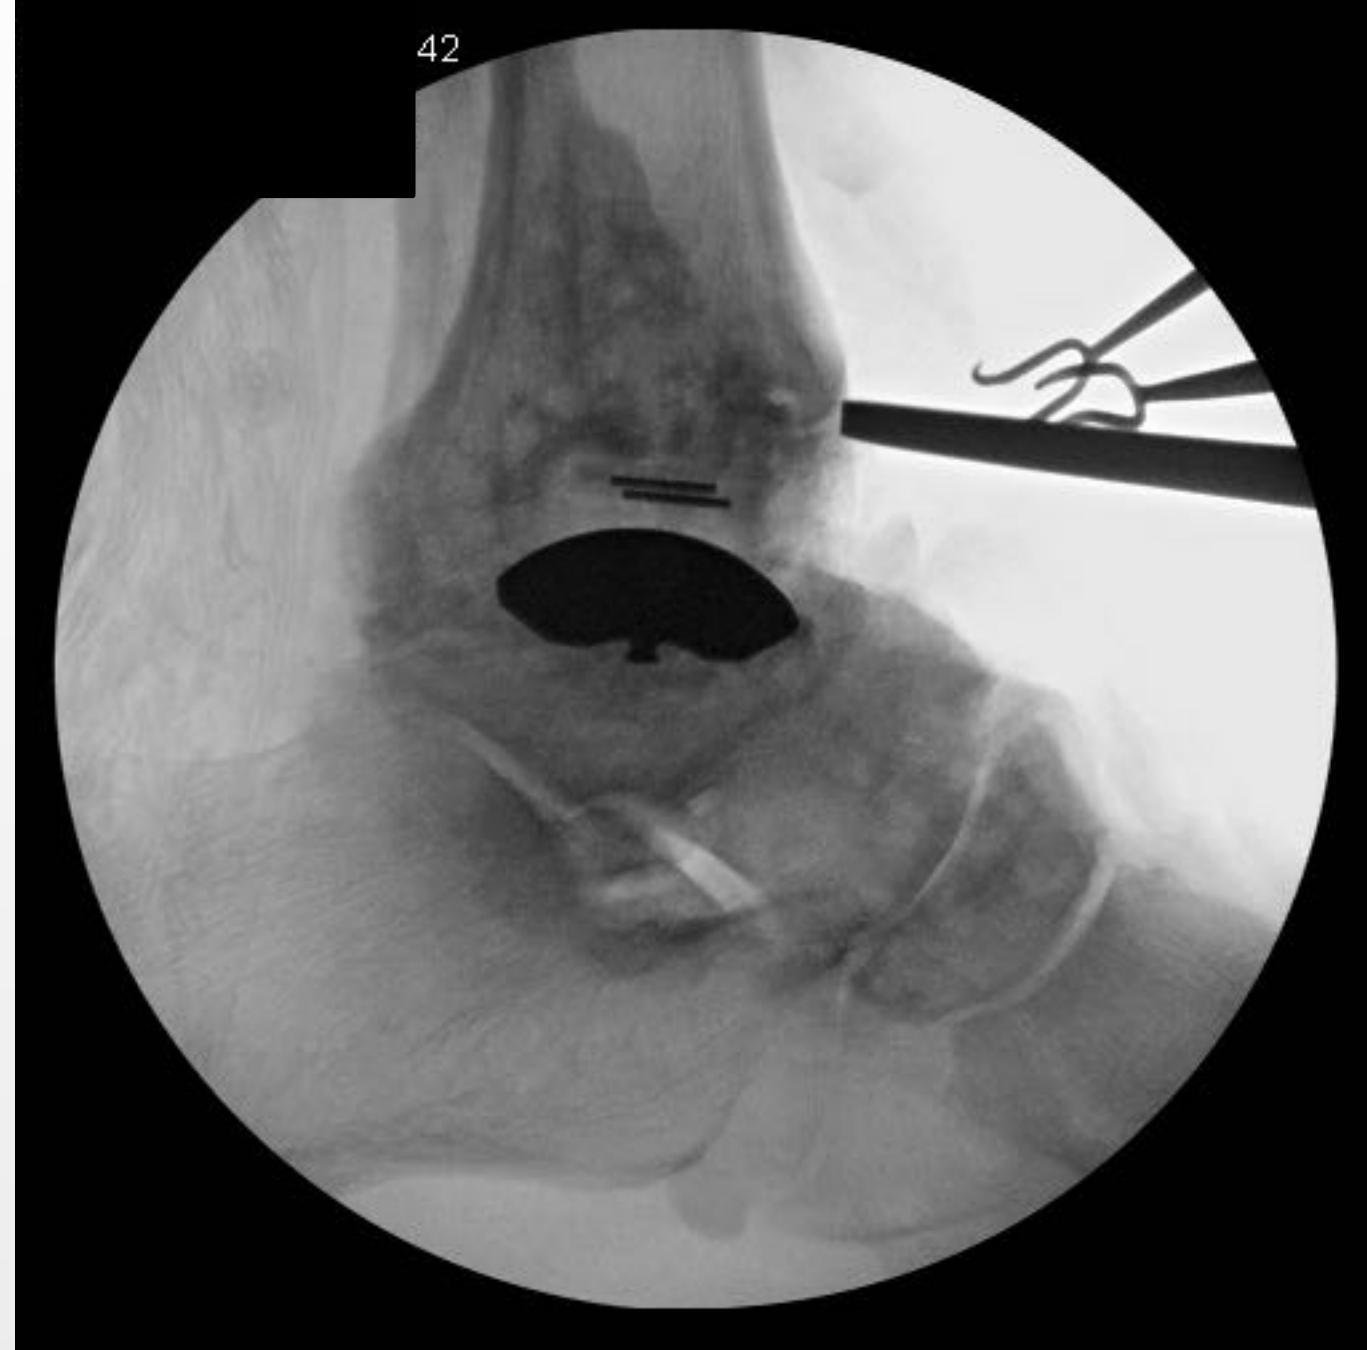
Photo 5.

PHOTO 5 & 6: Demonstration of an intra-op lateral projection while resecting the hypertrophic bone. The AP view illustrates the bone loss with resection of the hypertrophic bone and removal of the Oregon Ankle Implant.

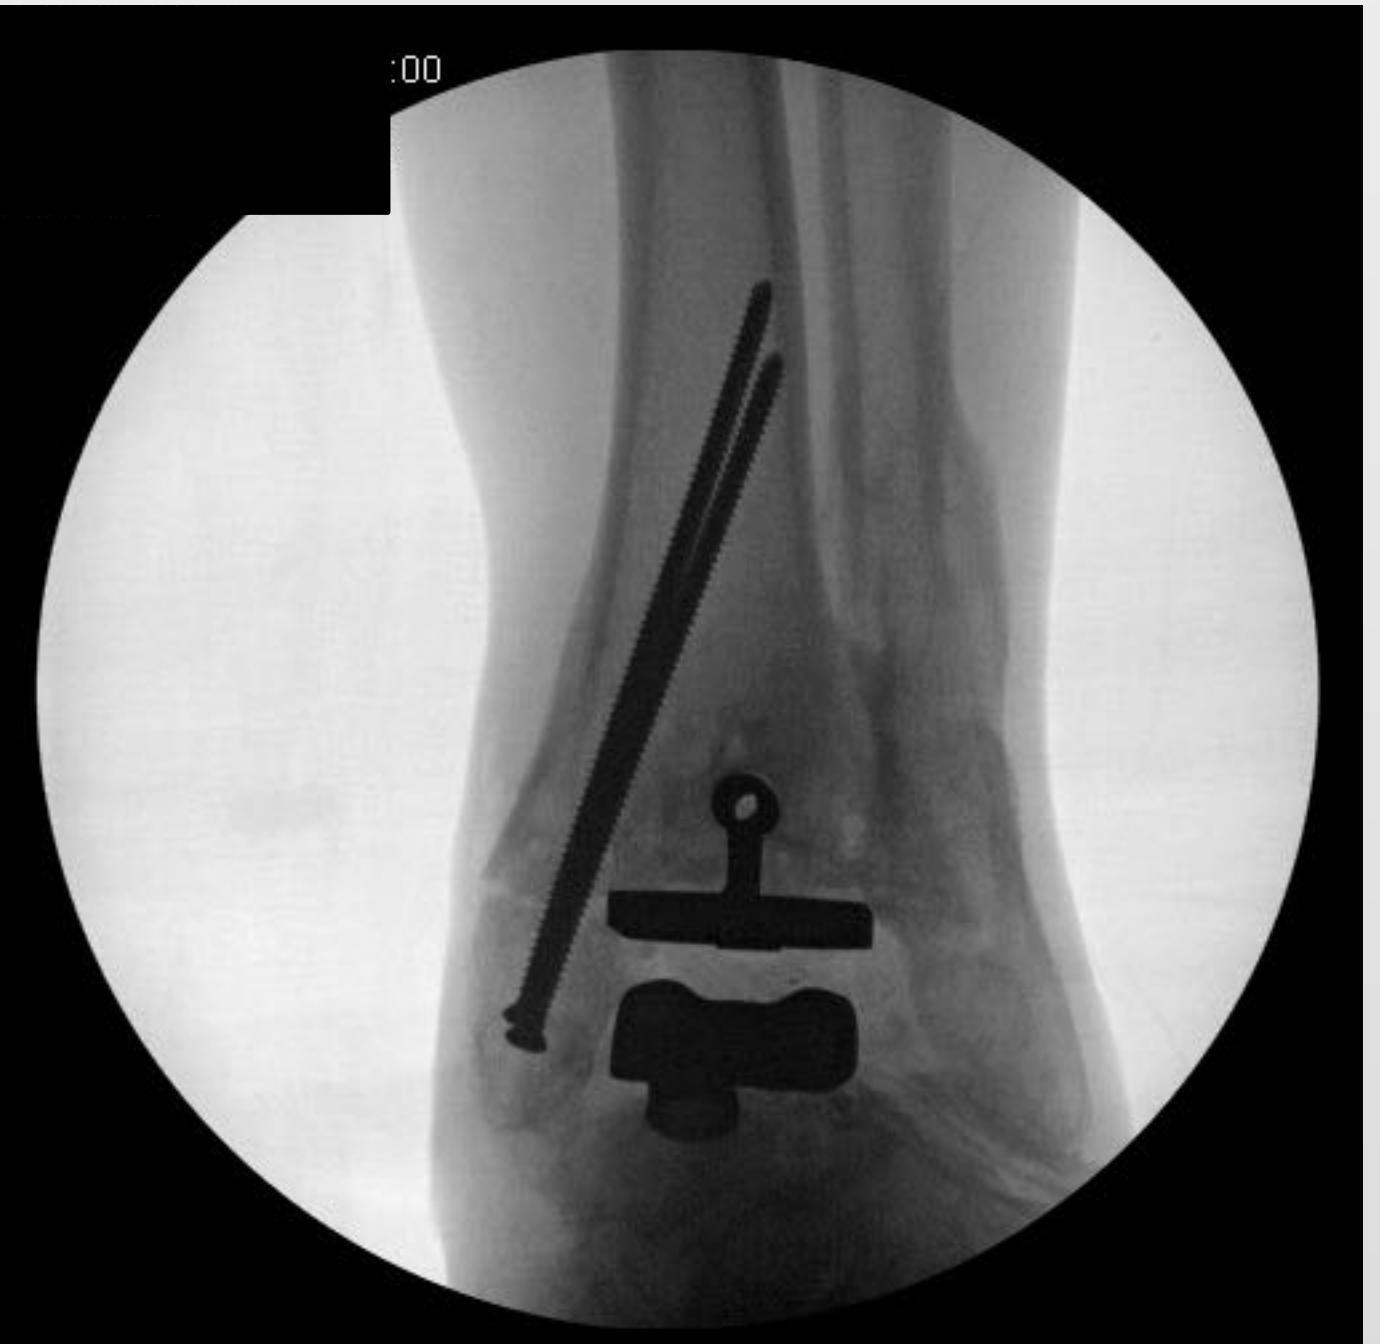
Photo 8.

**PHOTO 7 & 8:** Intra-operative views demonstrating implantation of a revision total ankle implant.

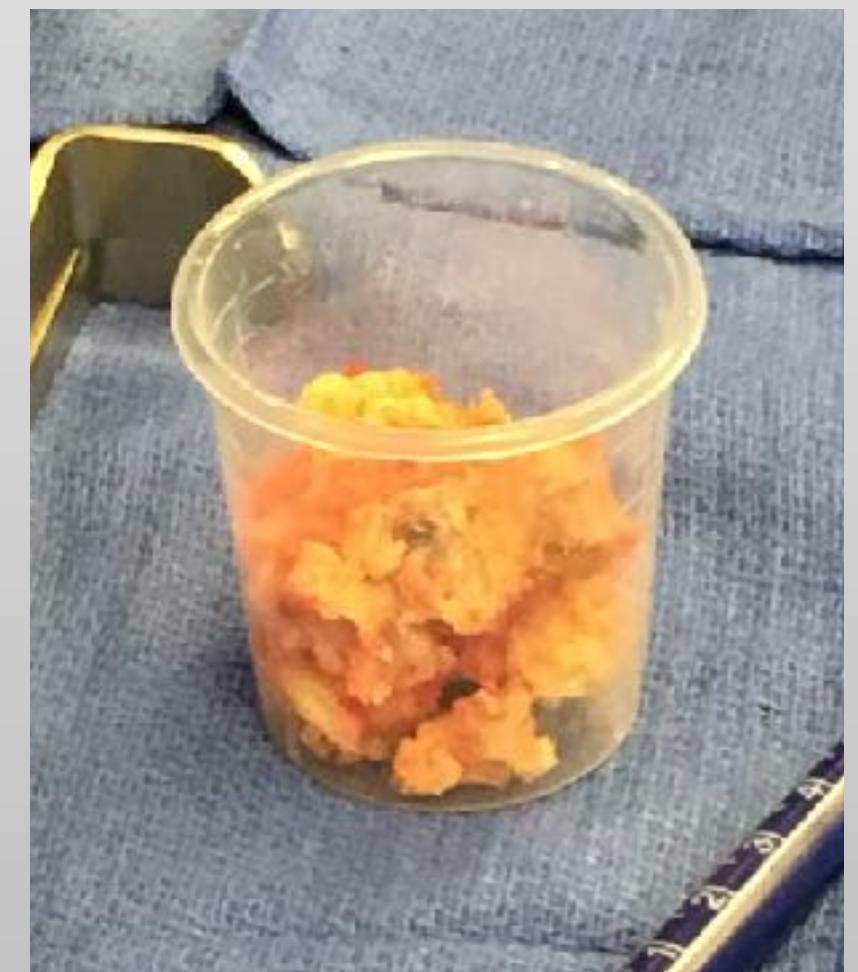
Photo 12.

PHOTO 11 & 12. Illustration of the amount of hypertrophic bone resected at the time of removal of the Oregon Total Ankle Implant. view of the Oregon Total Ankle Implant once removed from the patient.

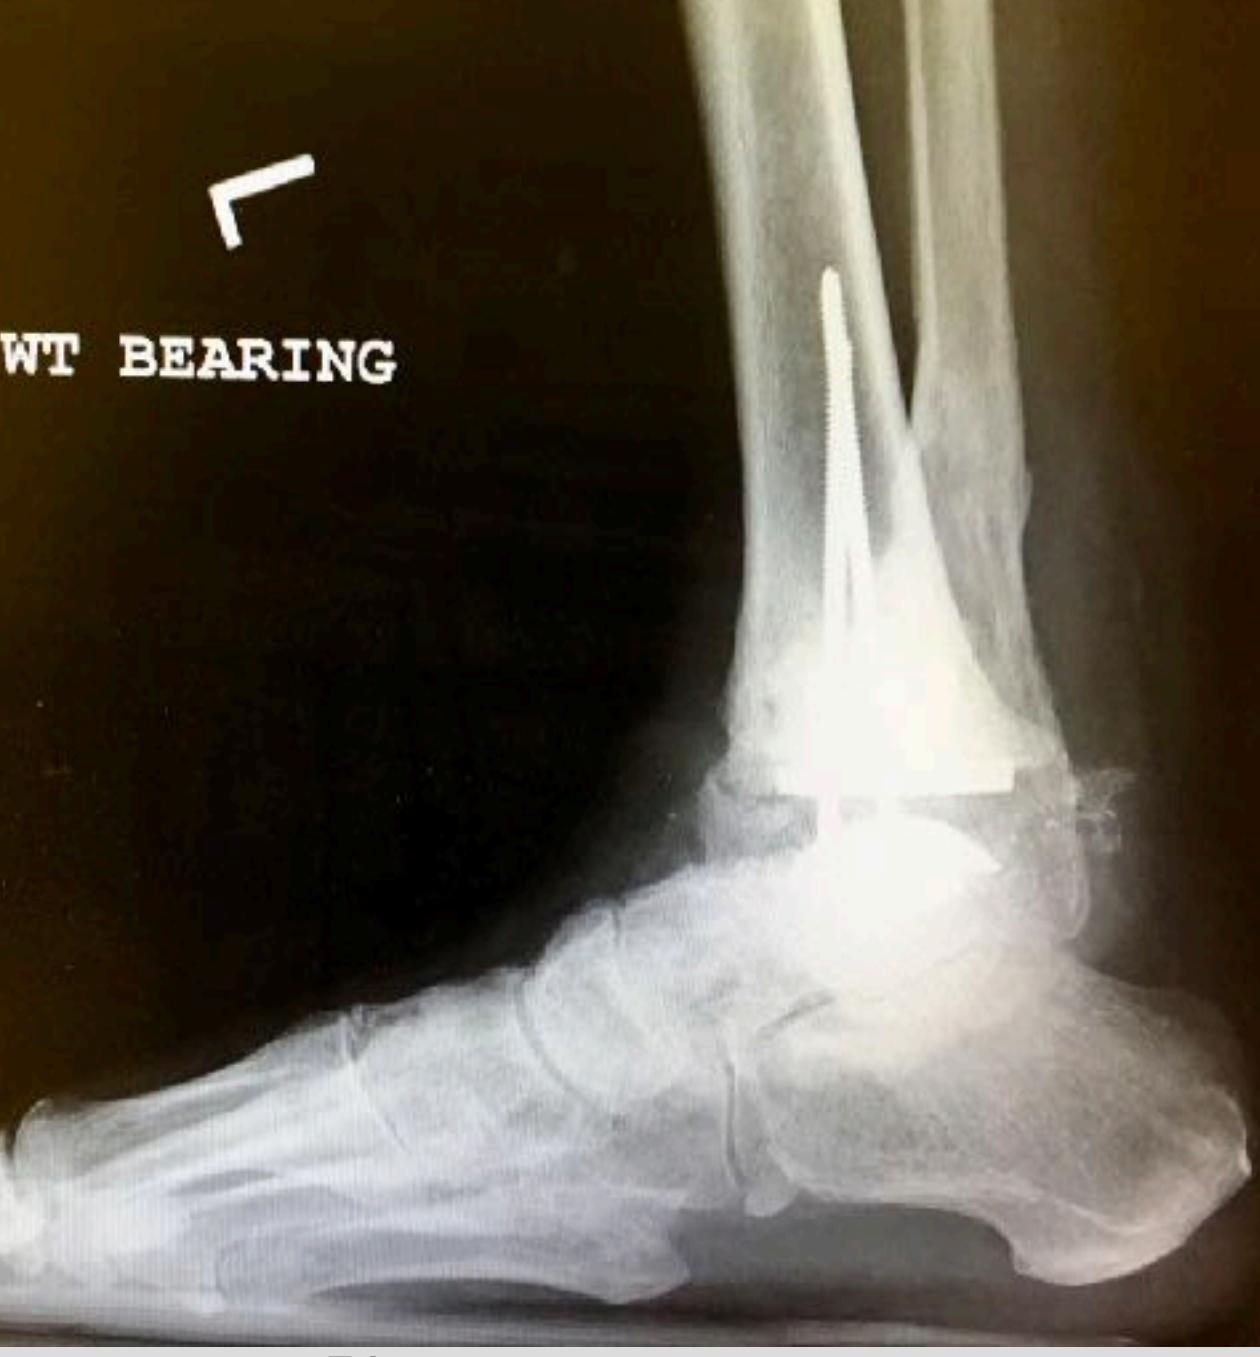
Photo 9

**PHOTO 9 & 10:** One year post-operative views with a revision total ankle implant.
