Surgical Treatment of Hallux Varus Secondary to a Traumatic **Avulsion Fracture**

Krista Getz DPM¹; Ernest Sorenson DPM²; Murray Kahn DPM³

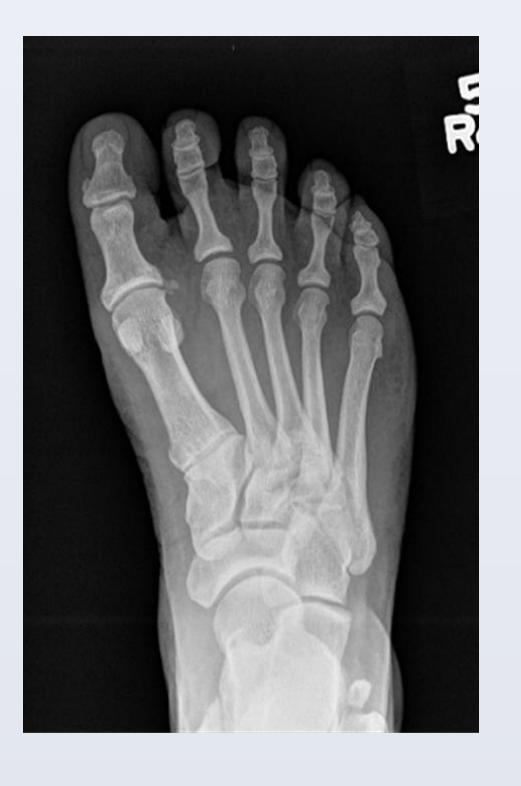
Figure 1. Initial clinic radiographs demonstrating subluxed fibular sesamoid with avulsion fragment to hallux proximal lateral phalanx

A 50-year old female presents with an injury to the right hallux. Patient reports hearing a "pop" while forcibly loud plantarflexing the right hallux then feeling immediate and She presented to the pain. after noticing an office increased medial drift of the right hallux. Physical exam revealed pain localized to the fibular sesamoid with significant pain with range of motion of the right 1st metatarsophalangeal joint A visible splay was also noted between the right 1st and 2nd digits.

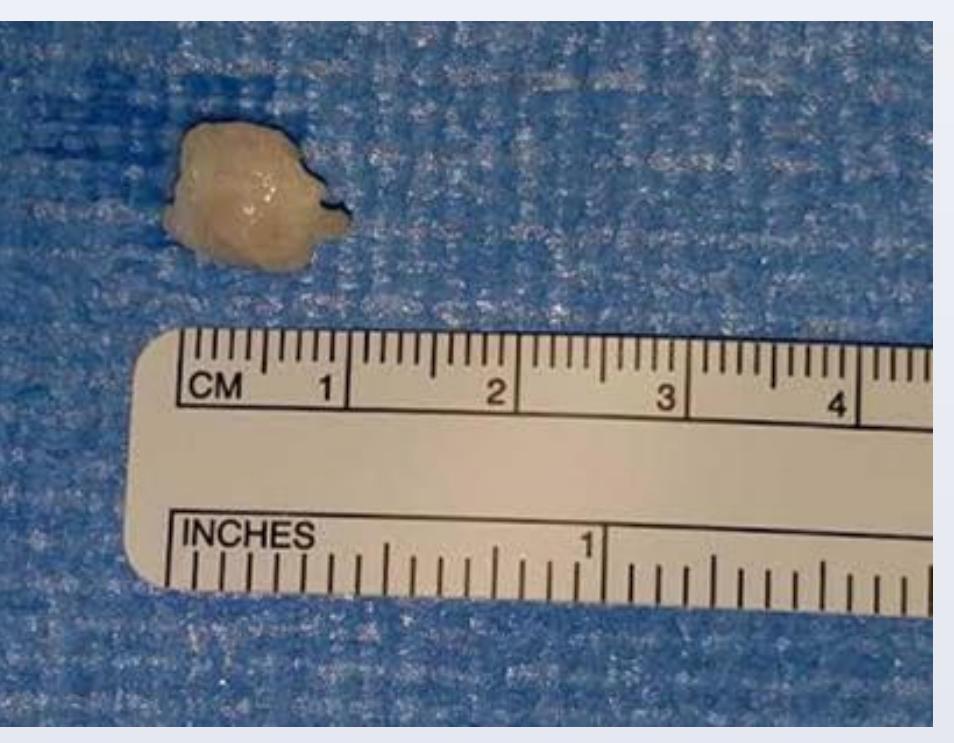
Figure 4. Avulsed fragment of the proximal phalanx measuring 10 mm in width

Surgical intervention was performed with a plantar approach for adequate visualization of fracture fragment and tendon. Intra-operatively, the non-healing fracture fragment was excised and measured 10 mm in length. The lateral head of the flexor hallucis brevis tendon was anchored into the base of the proximal phalanx using a 2-0 bone anchor with care to avoid the joint space of the 1st metatarsophalangeal joint. The toe was held in an abducted and plantar-flexed position utilizing a 0.062 in K-wire. Patient was placed in a surgical boot post-operatively and instructed to remain non-weightbearing.

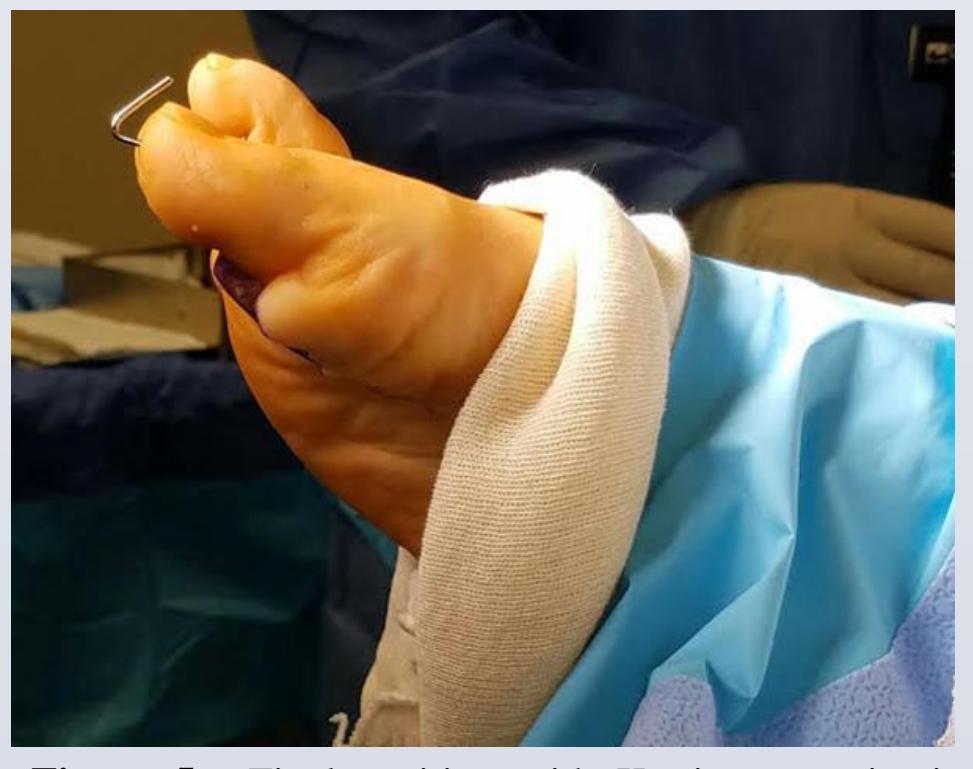
Figure 5. Final position with K-wire to maintain abducted and plantarflexed position.

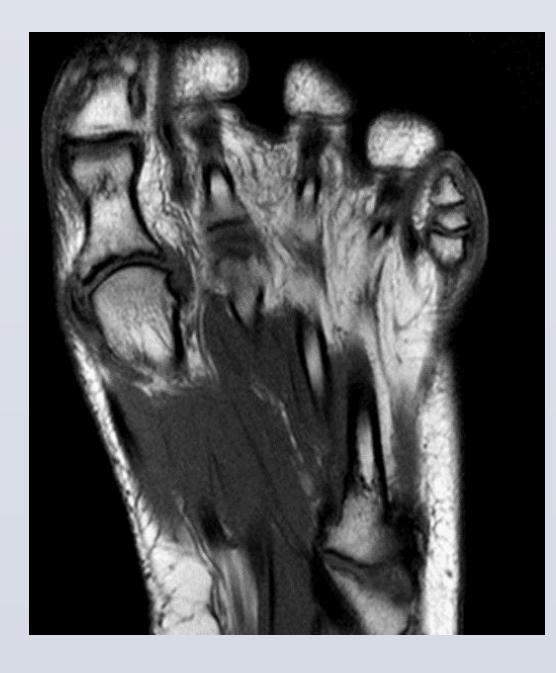
Figure 3. Transverse plane STIR MRI demonstrating increased varus drift of the hallux

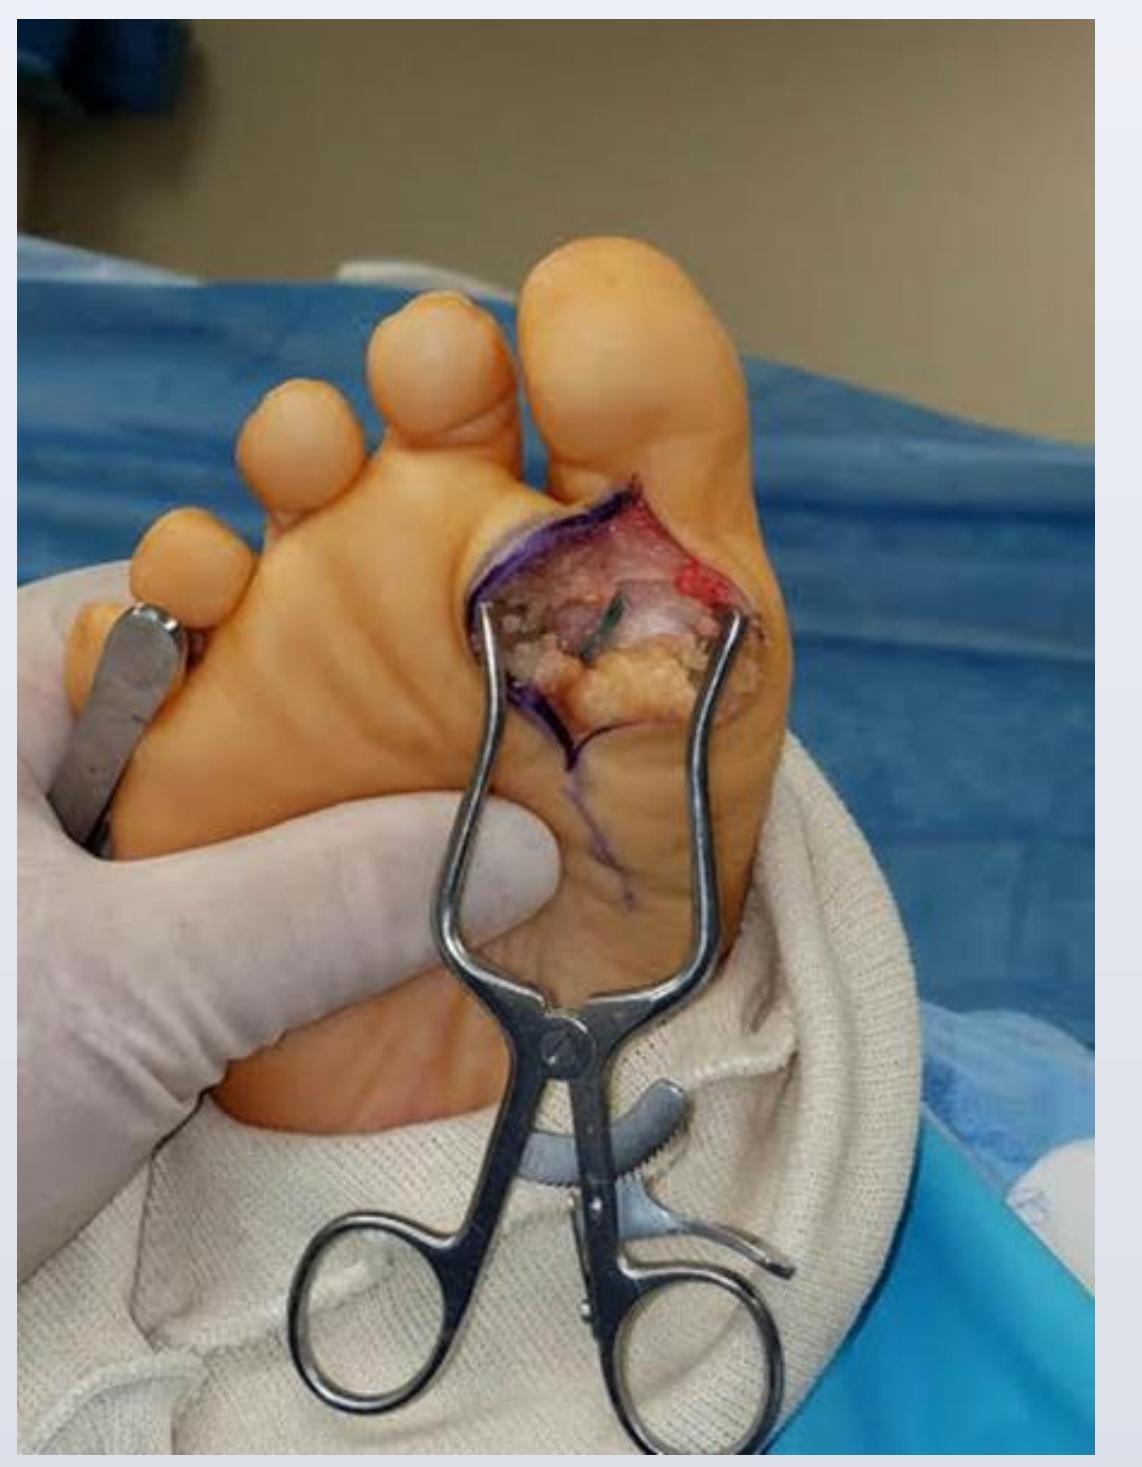
Figure 6. Reattachment of the lateral head of the flexor hallucis brevis with the proximal phalanx base utilizing a 2-0 bone anchor. Adequate visualization of the tendon and base provided by a plantar approach.
