Salvage of malunion of 1st MPJ fusion with the utilization of hemi-implant

Mashail Manzur, DPM, Sarina Epstein, DPM

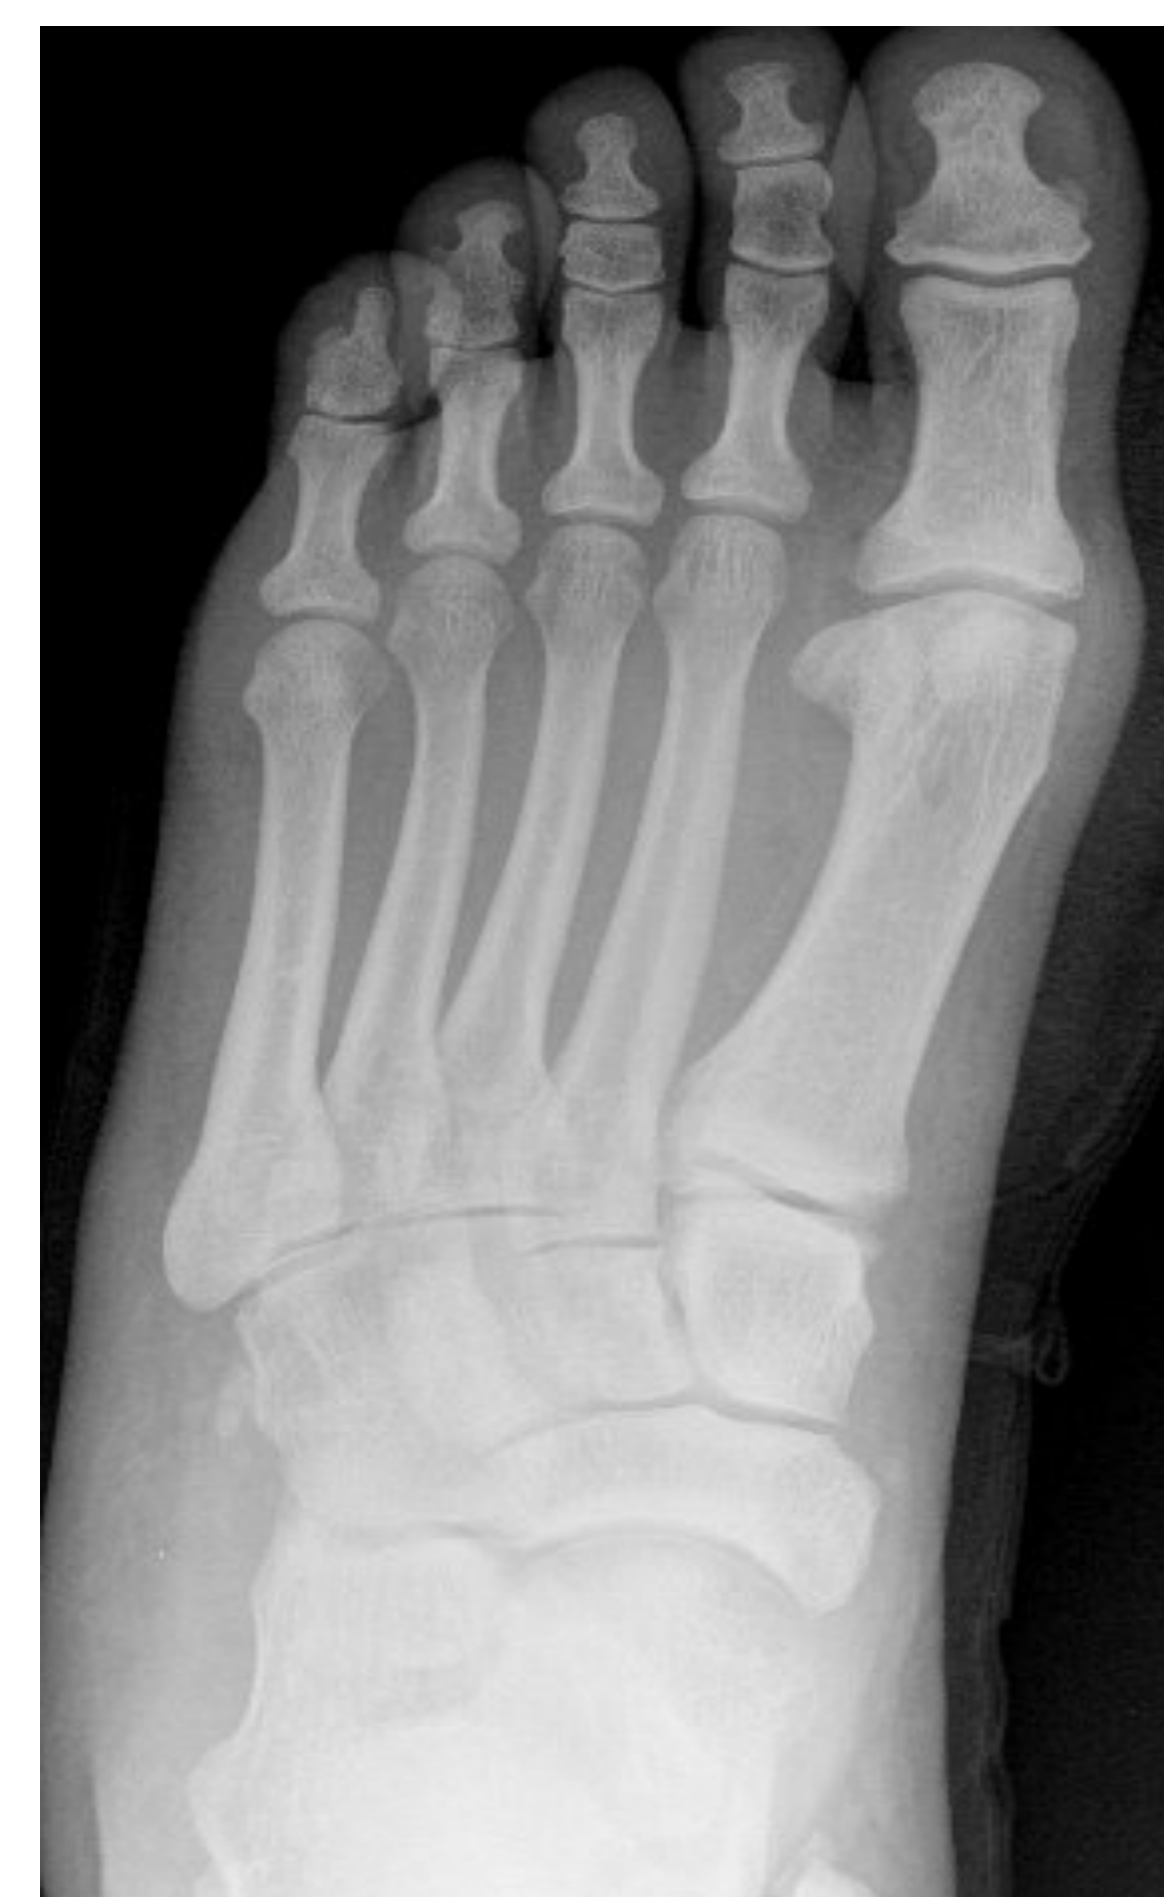
2017

1 patient underwent bunionectomy in 2017, bunionectomy with fixation in mid 2018, then proceeded to 1st MPJ fusion in late 2018, and finally converted to a hemi implant in 2019. Patient is currently pain free and gained full functionality and ROM of his 1st MPJ.
